NORTH VANCOUVER PIPE BURST REQUIRES CAREFUL PLANNING

Close proximity to storage silos, poor ground conditions and clogged storm sewer pipe puts trenchless contractor to the test

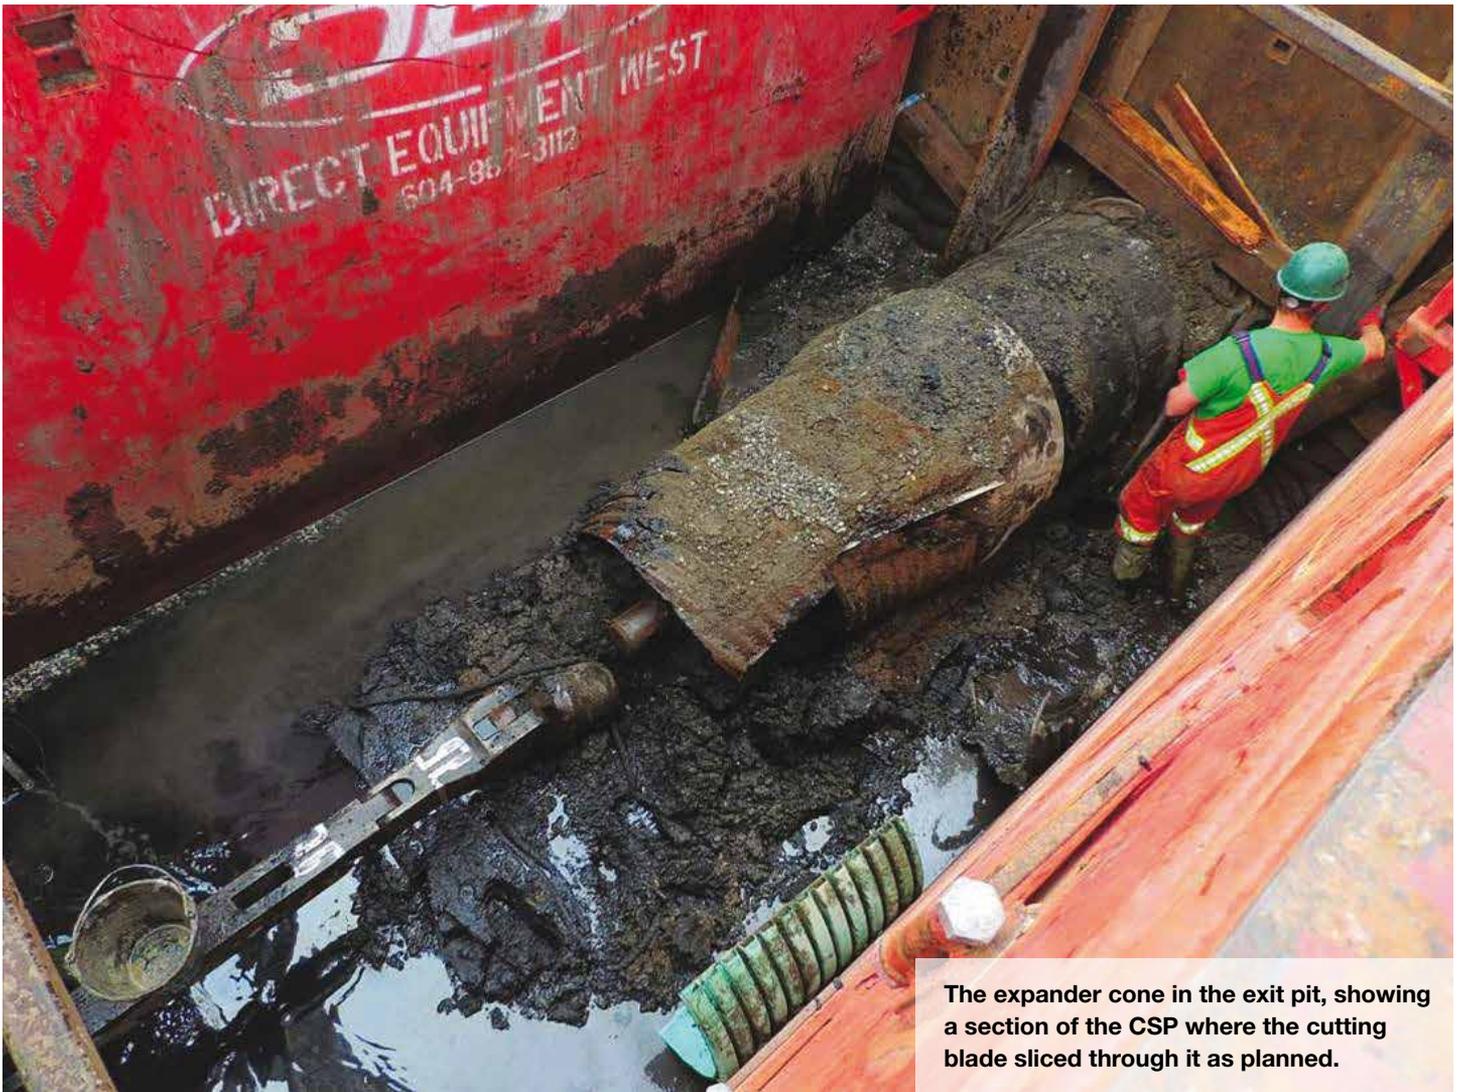
The expander cone in the exit pit, showing a section of the CSP where the cutting blade sliced through it as planned.

Expander cone blade cuts CSP

The pipe now ready to be burst, the contractor cut the CSP using a sharp blade on the expander cone. PW Trench-

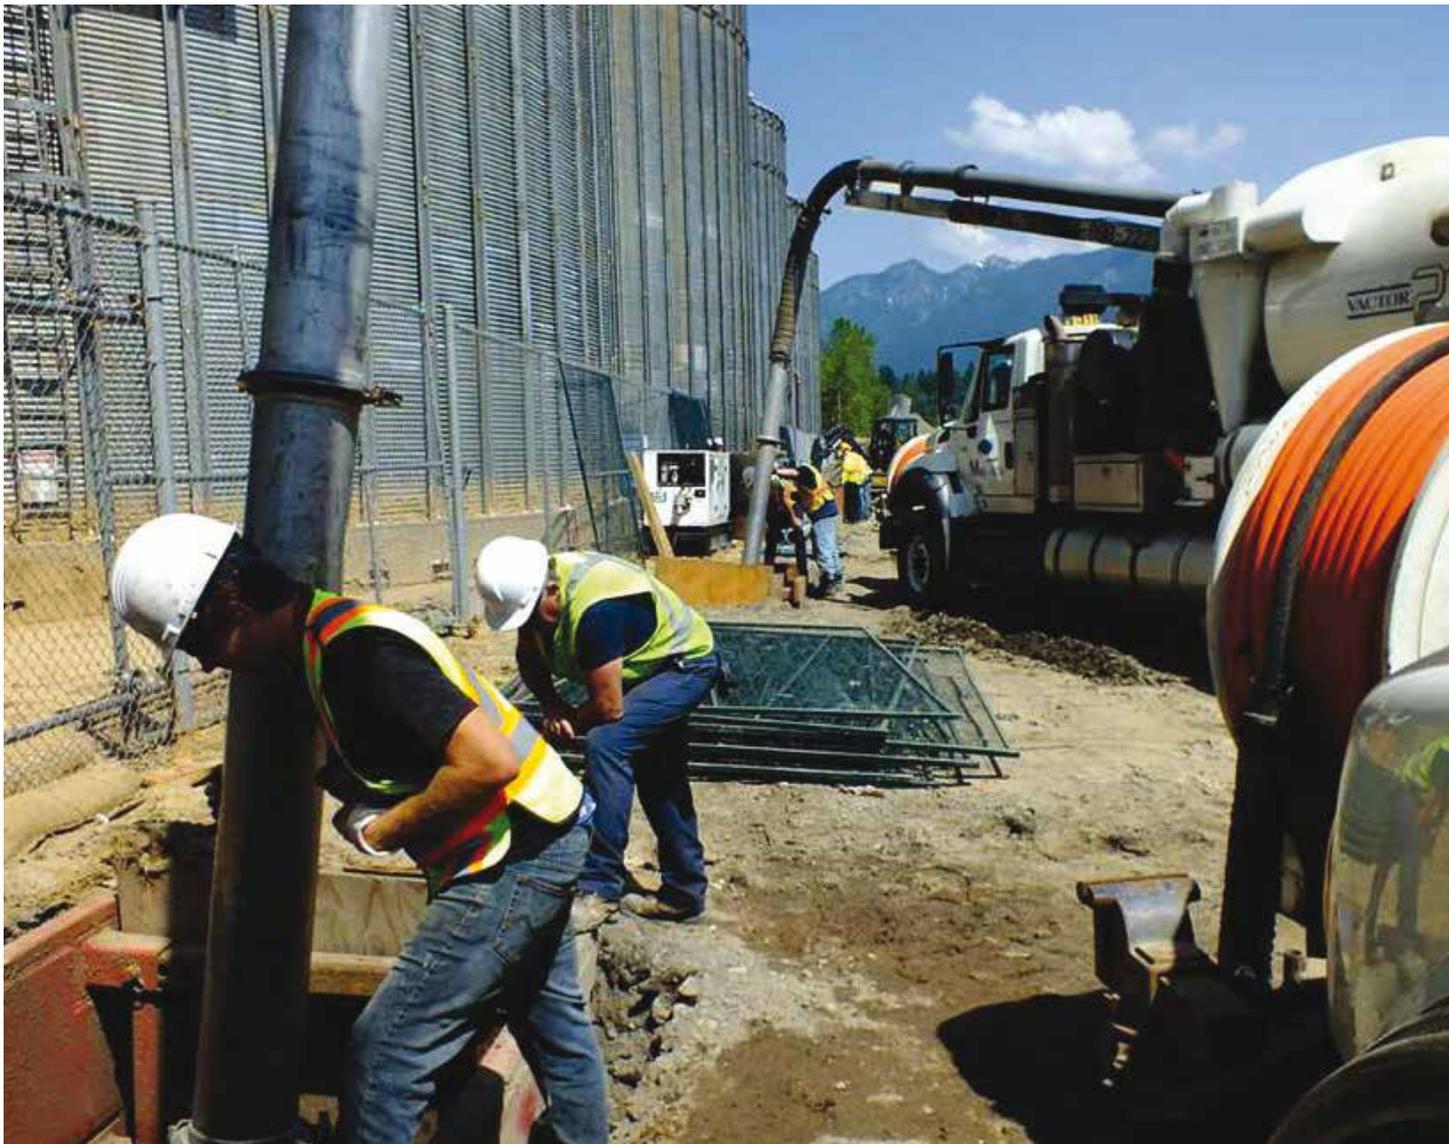
Top: The Vermeer Navigator HDD drill used to drill through the existing CSP pipe to pull through the bursting rods. Right: The McElroy 1648 fusing machine that was used to fuse the pipe together. Note the proximity of the silos to the pipe.

PW Trenchless Construction was concerned that the 2500G could push the rods through the sides, top or bottom of the CSP. To get around the problem, they used an HDD rig to drill through the pipe from the entry pit to the exit pit, thus removing the debris that was in the pipe this risk. “This allowed us to attach the bursting rod, and use the drill rig to pull it through the pipe,” said Deacon.
